Evaluation of 532 nm Q-Switched Nd:YAG Laser and Acid Etching of Class V Composite Restoration: Comparative Histological Study

Hayder K. Ridha and Lehadh M. Al-Azzawi

Department of Oral Maxillofacial Pathology, College of Dentistry, University of Baghdad, Baghdad, Iraq

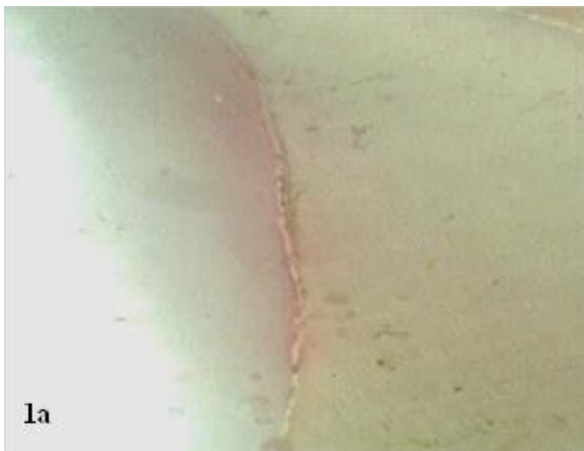
Fig. (1-a): Group1. Sample with score 1, revealing microleakage obviously to the half depth of the cavity, X60 1a

Results of group I (Acid etching only): In this group, the surface of the tooth was treated with 37% phosphoric acid and the histological sections of samples revealed two distinct zones (levels) to be recognized as a microleakage. The first zone or level is the most oral one where it begins from the oral surface of the tooth and below down to about 1mm as shown in Figure 1a, while the second zone starts from it and below to also about 1 mm down to the pulp direction where the full thickness of the cavity was involved in basic fuschin dye discoloration (score 2) as demonstrated in Figure 1b, and Figure 1-c. The third zone is not affected by microleakage.

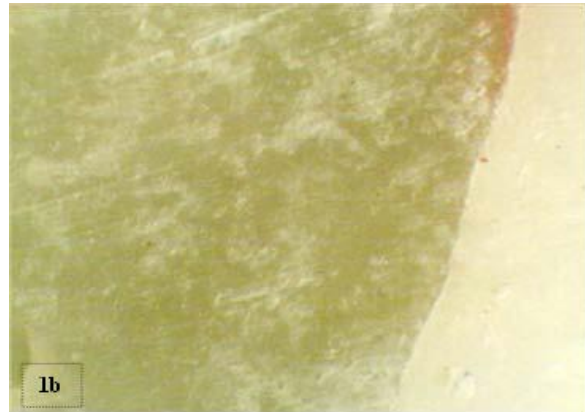
Fig. (1-b): Group 1. Sample revealing microleakage in the second level (score 2) dye penetration to full depth of the cavity, X60 1b

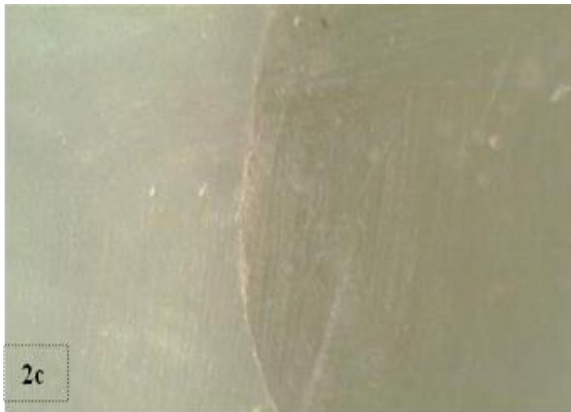
Fig. (2-c): Group 2. Score 3 (floor of the cavity) revealing that no dye penetration within or below this zone, X60. 2c

Results of group II (Q-Switched Laser etching only): In this group, the Q-switched Nd:YAG laser with 532 nm was used to etch the tooth surface instead of the routine acid etch. The histological sections revealed also 2 zones or levels of microleakage, the first one is the most outer part of teeth(oral) down to the half of the depth of the class V cavity as illustrated in Figure 2-a, while the second layer penetrates down to the full depth of the cavity in the pulpal direction as seen in Figure 2-b, but not involving the floor of the cavity nor the axial wall (score 2) as shown in Figure 2-c.

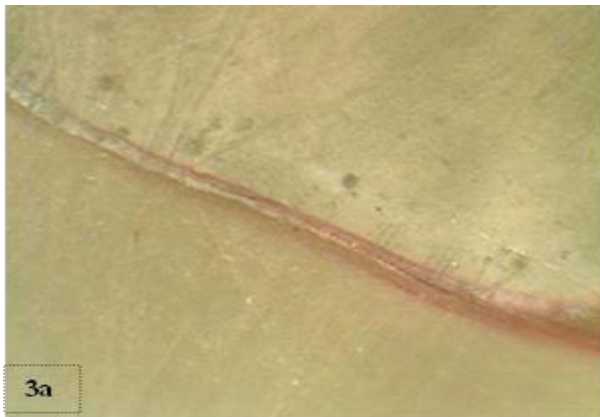
Fig. (3-a): Group 3. Sample with score 1 revealing microleakage between the walls of the composite and the tooth surface, X60. 3a

Results of group III (Q-Switched Nd:YAG Laser etching then acid etching). In this group the teeth surfaces were conditioned with the Q-switched Nd:YAG laser irradiation and then the teeth surfaces were etched with the 37% phosphoric acid. The histological findings revealed that the microleakage of the dye through the composite-teeth walls were much less. Although the two previously mentioned layers still present (score 1) as shown in Figure 3-a, the number of the second layers or zones were less. Only 2 samples showed microleakage at this level (score 2) as illustrated in Figure 3-b, where the dye is not totally penetrated through the entire sectional slice as shown in Figure 3-c. Results of group IV (Acid etching and Q-Switched Nd:YAG Laser etching).

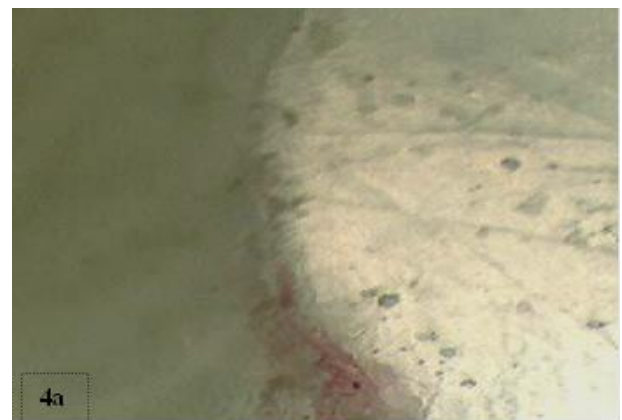
Fig. (4-a): Group 4. Samples revealing microleakage at score 1, dye only penetrated to the half of the depth of the cavity with minimal spread,X60. 4a

In this group, the teeth surfaces were etched with 37% phosphoric acid and then were conditioned with the Q-switched Nd:YAG laser irradiation. The histological sections of the samples gave the best impression of the least microleakage that happened among the tested groups, where the penetration could be diagnosed only in one zone or level which is the most outer (oral) layer of the samples (score 1) as shown in Figure 4-a. The microleakage is localized only in the most outer (oral) layer in all the slides, the basic fuschin dye is not penetrated any further below down as shown in Figures 4-b and 4-c.

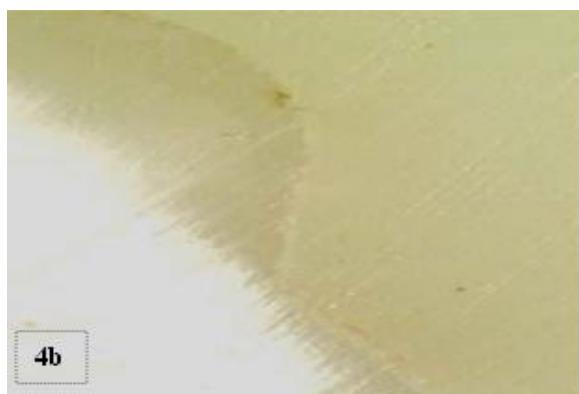
Fig.(4-b): Group 4. Revealing no microleakage at score 2 (no dye penetration below the half of the depth of the cavity), X60. 4b

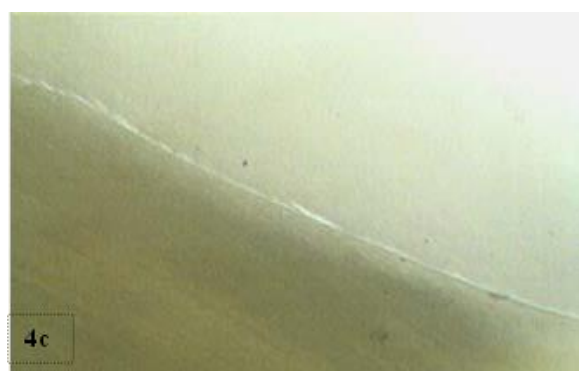
Fig. (4-c): Group 4. Sample at score 3 revealing no dye penetration at the floor of the cavity, magnification X 60. 4c
